AWARD

XSTRATA AERIAL WALKWAY, KEW

ARCHITECT - MARKS BARFIELD ARCHITECTS

STRUCTURAL ENGINEER - JANE WERNICK ASSOCIATES LTD

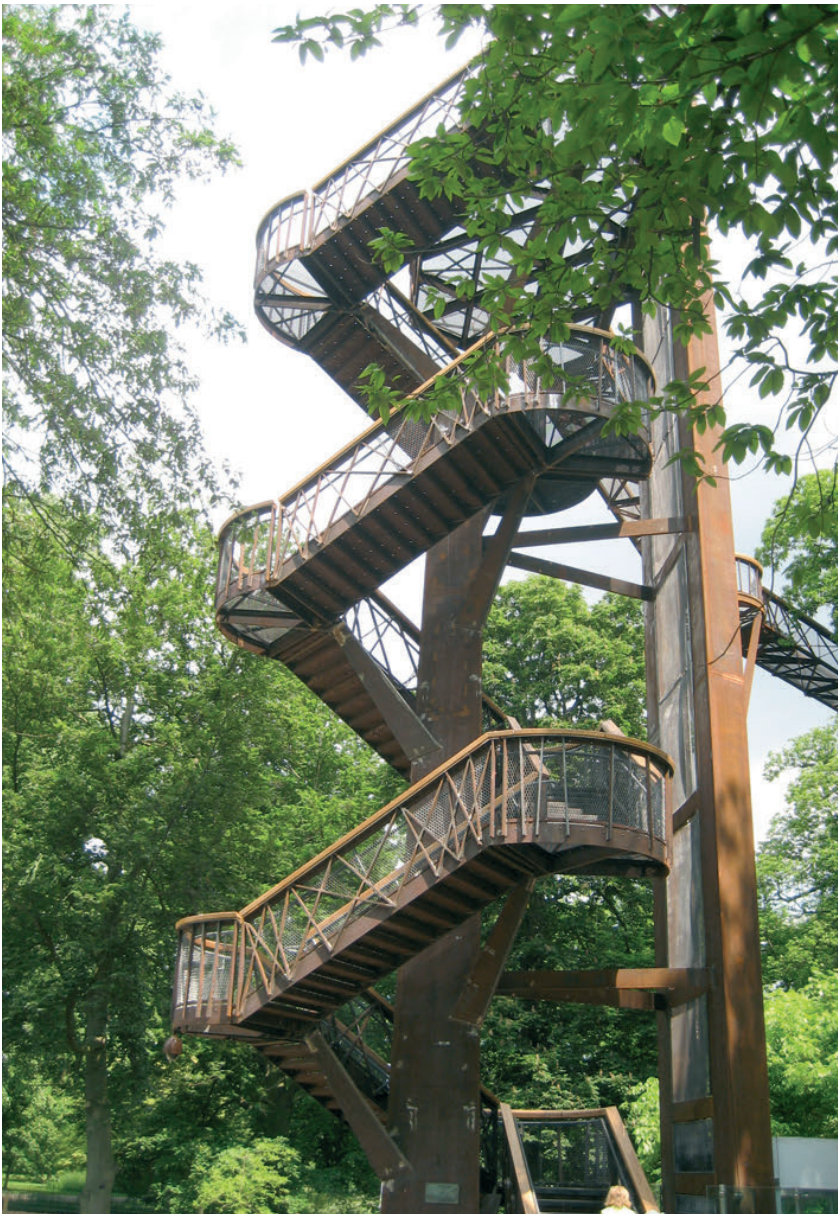
The walkway is approached via a Rhizotron and then visitors ascend to the tree canopy, via stairs or a lift. It was important that the walkway should not compete with the trees. By using the balustrades as trusses spanning between slender pylons, a simple yet elegant solution was found. The choice of weathering steel was crucial; all the elements are made from pieces of plate welded together.

Each pylon is a cantilever, supported by a group of four piles that resist the overturning moments. The triangular section is an efficient closed section, and looks smaller than an equivalent square. It splits into three tapering branches that support the circular node platform. A larger pylon supports the stair and lift. Halfway round, another larger pylon carries a “classroom” platform.
